MINEVILLE, NEW YORK: A CONCRETE INDUSTRIAL VILLAGE  
IN THE HEART OF THE ADIRONDACK FORESTS

A THESIS

1990

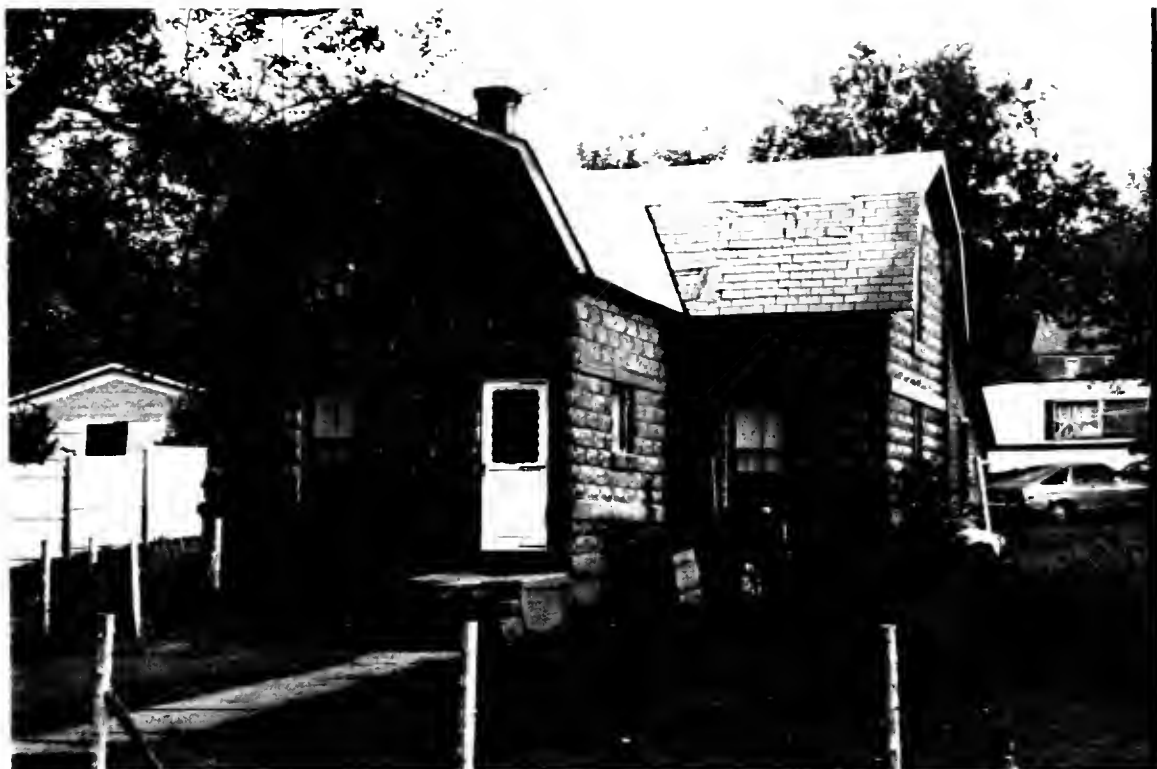
Figure 28

In general, the tailings block houses are in good condition. However, certain types of deterioration have occurred within each of the six house types. The Type One houses are generally in very good condition, in part because of their small size, the simplicity of their design, and their lack of projecting decoration. No settlement cracking is visible in any of the Joyce Road houses, except in the "monolithic" concrete entrance steps (See Fig. 28).

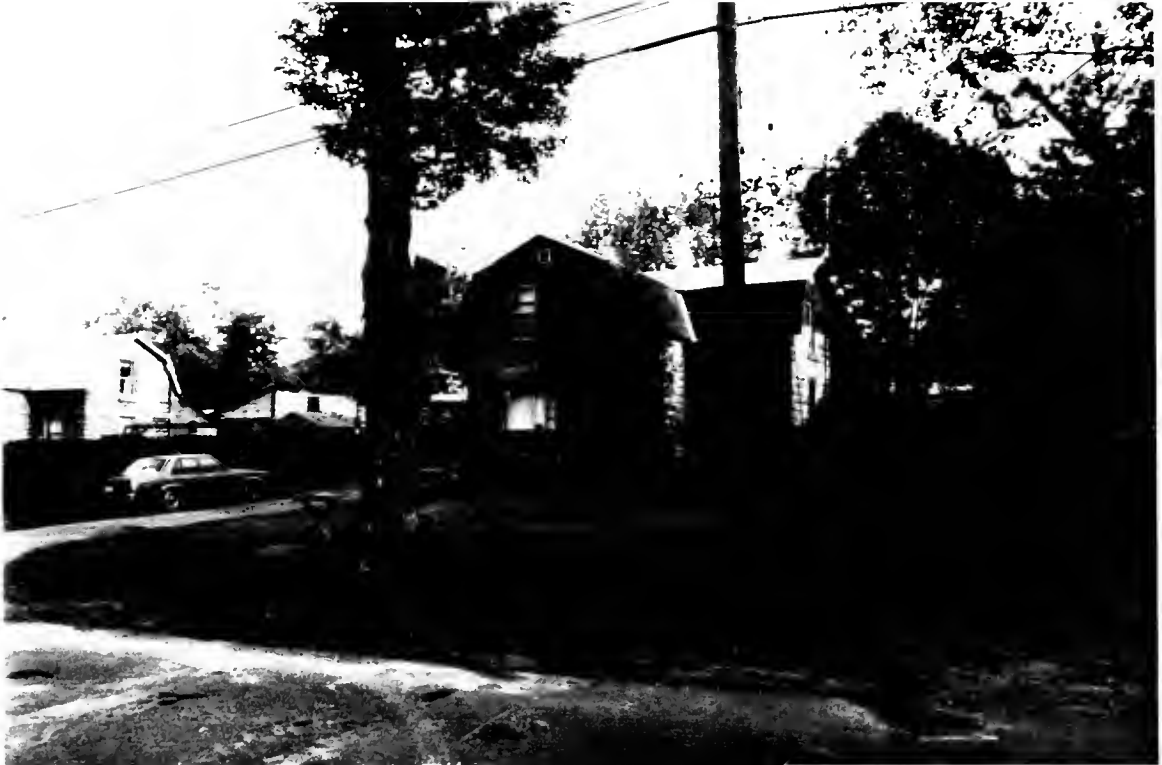
Figure 29

texture of the rough-faced block below. Owners then covered up the uneven block at upper gables with wood siding. In some cases, no siding was used, but the gable peak was painted, as at 484 Joyce (See Fig. 29). In the case of 405 Foote Street, a Type Three house, stucco was applied directly to smooth-faced tailings block, and immediately failed (See Fig. 70). Vertical board siding was added to cover the stucco (See Fig. 33).

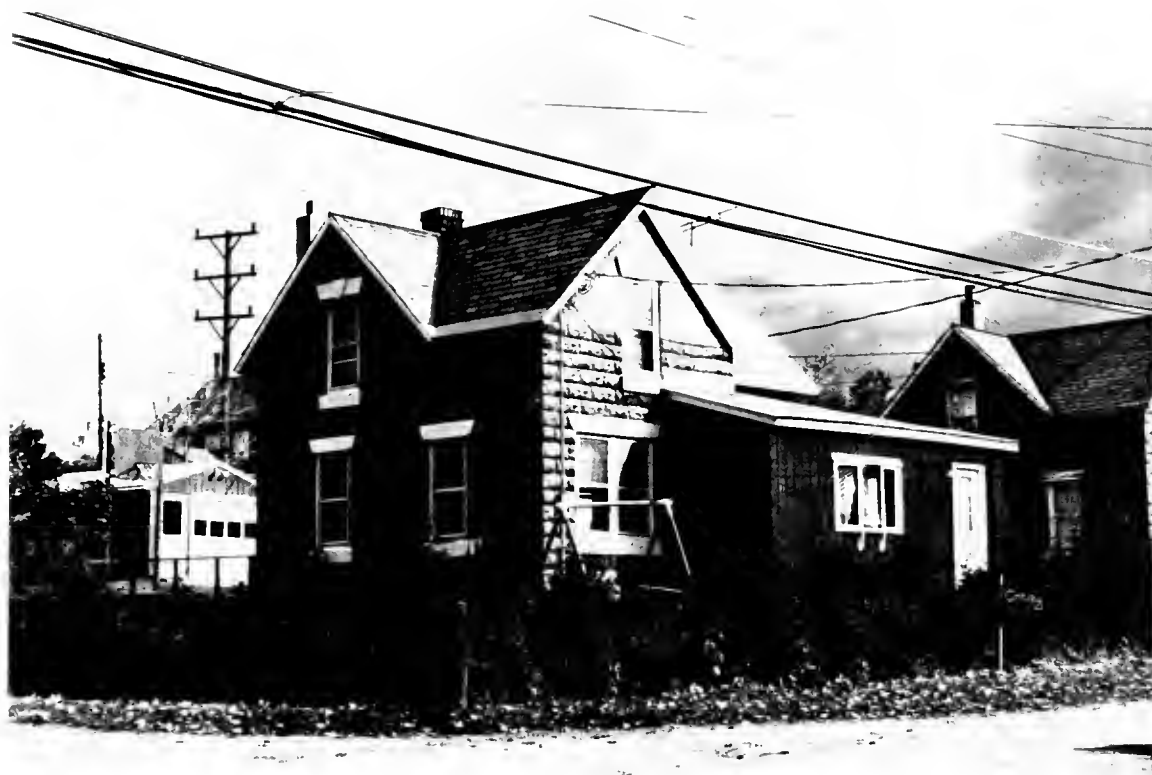
Figure 30

tailings concrete slab porches have been largely replaced as they were filled in to create additional rooms. The original porches were built directly on the ground, with no damp-proof course and no ventilation. As a result of this practice, the highly decorative porch of No. 509 Plank Road deteriorated rapidly and was removed by the mining company for the present owners in the late 1940's.<sup>34</sup> Other porches undoubtedly underwent similar deterioration, leaving occupants with no incentive to preserve the original porch configurations. The poor design detailing of the porches, combined with the difficulty in adding to the tailings block houses through exterior masonry walls, has led to their redesign and enclosure (See Fig.'s 30-33).
